**PROJECT MEMORANDUM****SUNRISE POWERLINK PROJECT – PRELIMINARY INCIDENT REPORT NO.1**

Date: June 15, 2011
To: Interested Parties
From: Billie Blanchard, CPUC Project Manager
Subject: Sunrise Powerlink Construction Helicopter Incidents June 7 and 10, 2011

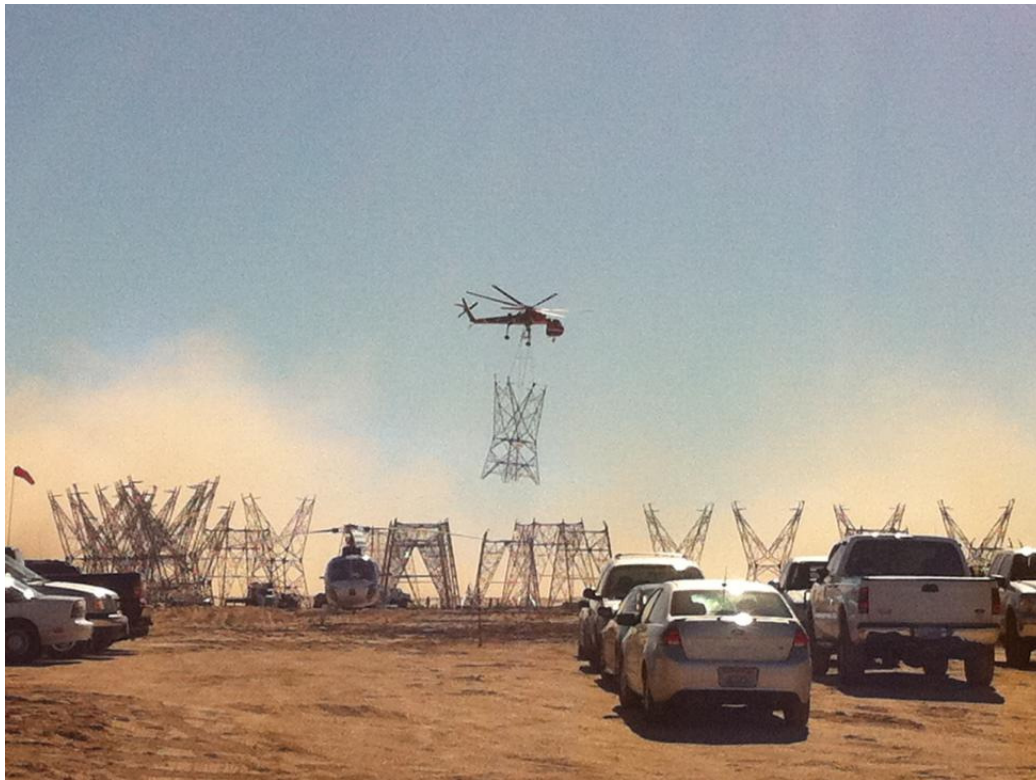
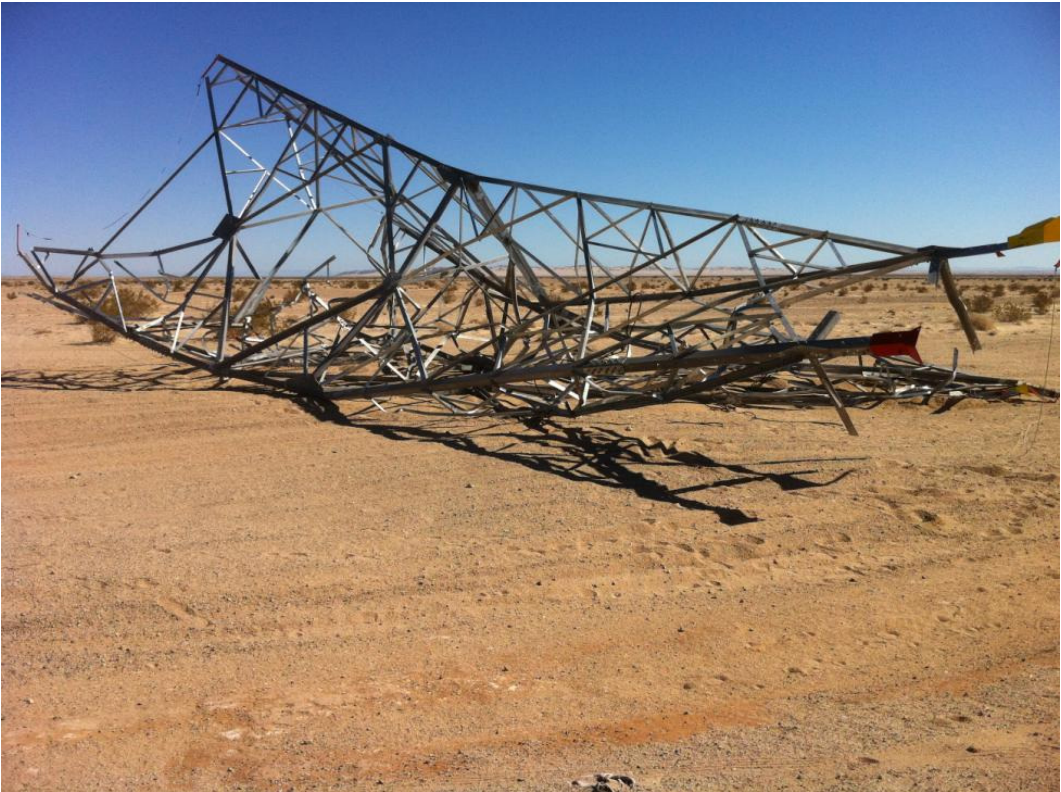
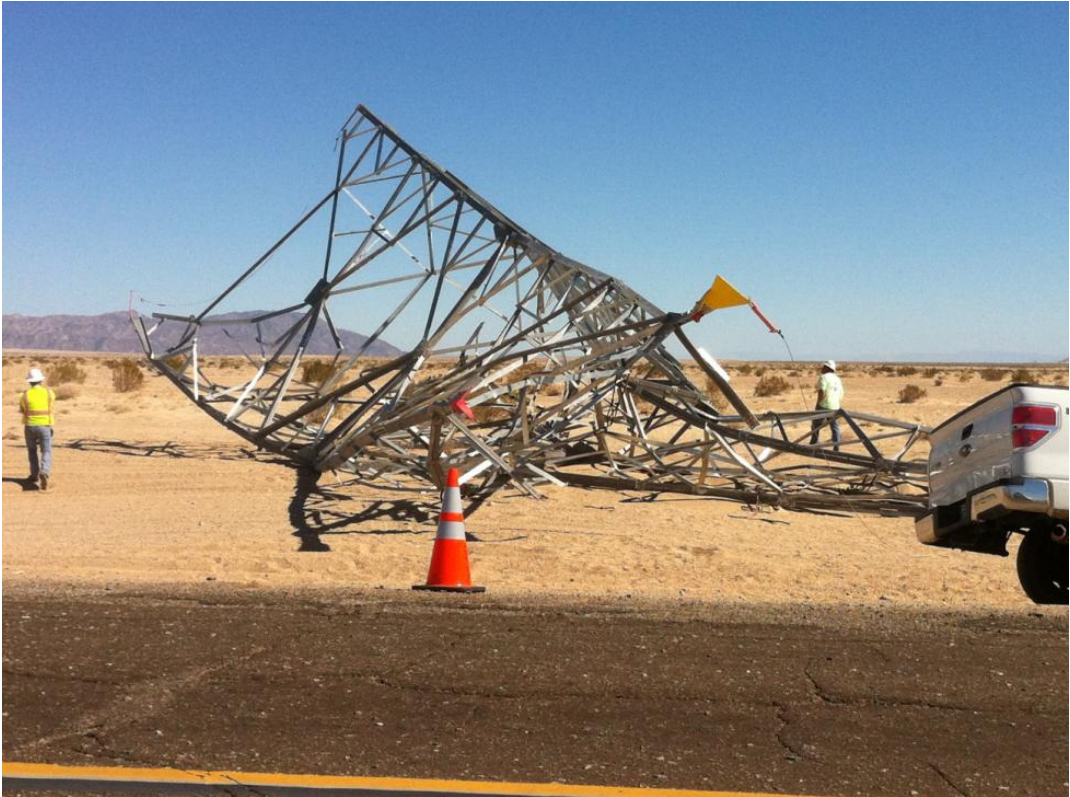
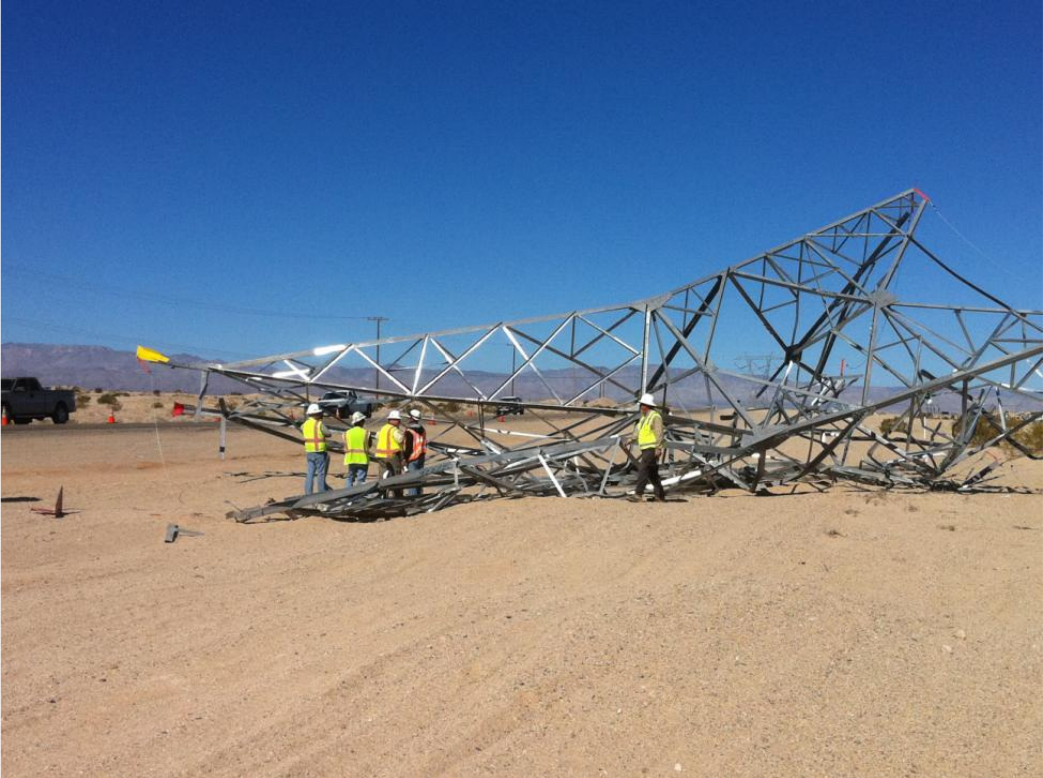
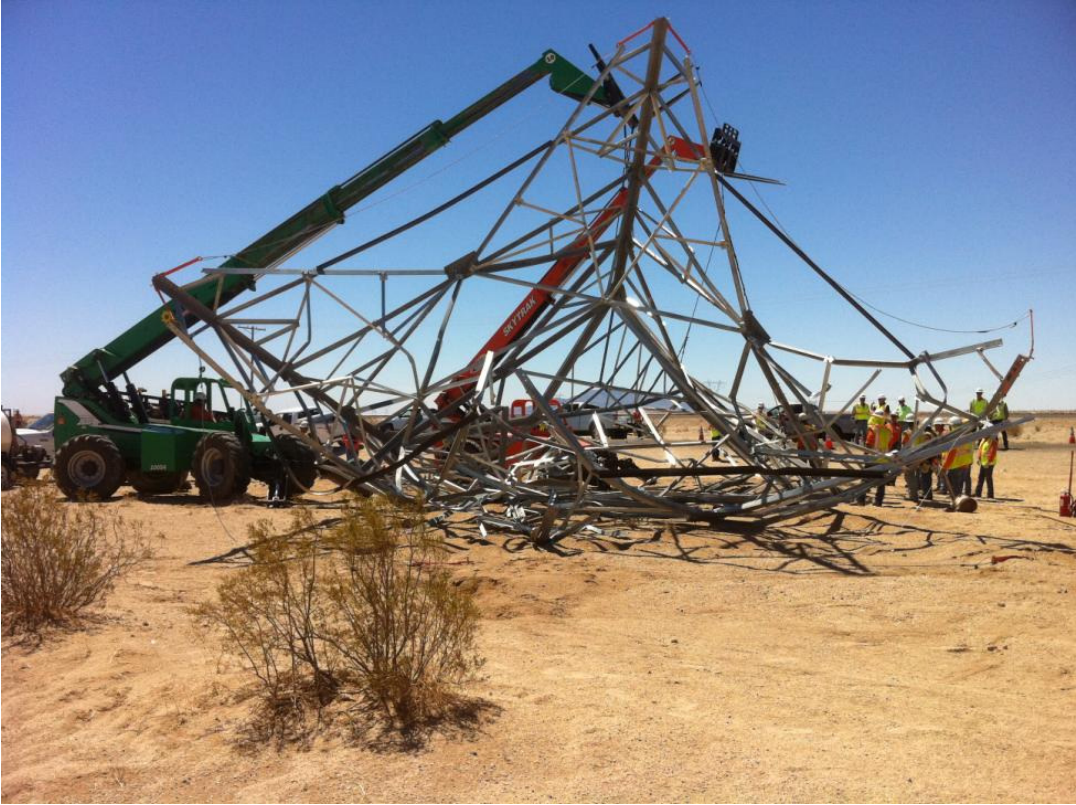
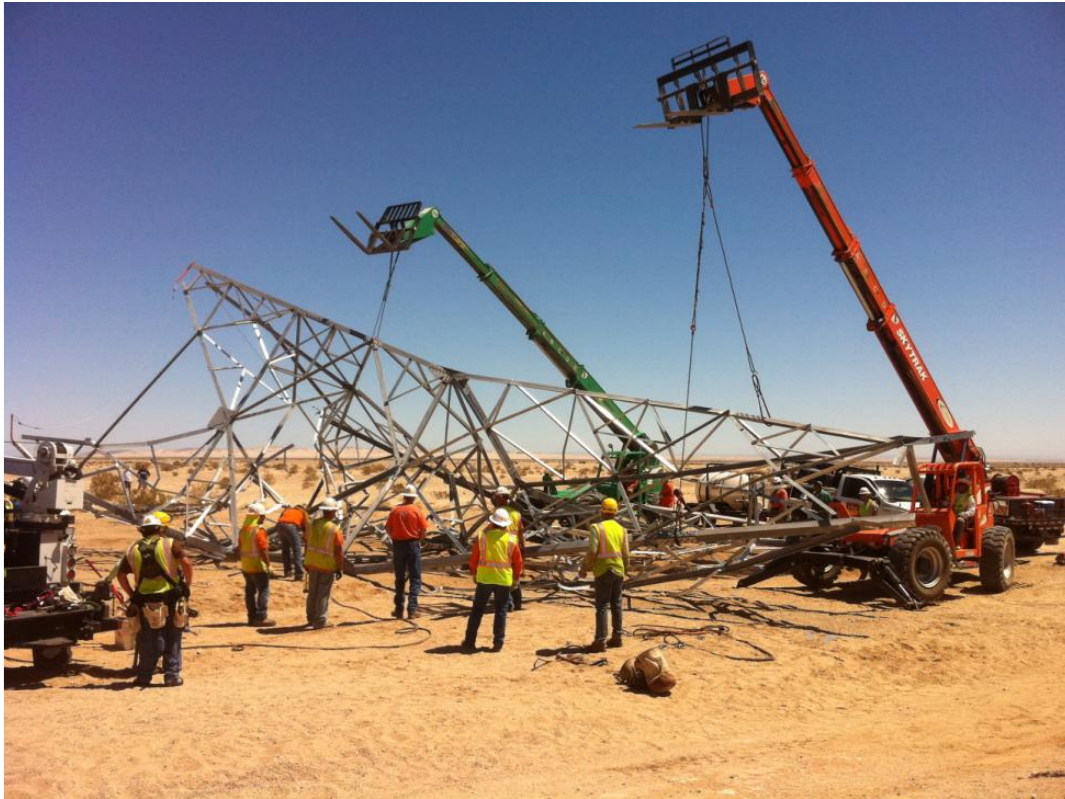
Photographs - June 7, 2011 Incident

- The load was approximately 16,400 lbs.
- The helicopter began its routine climb out of the yard.
- About five to ten seconds later, when the payload was approximately 150 feet above the ground, all four hooks securing the payload made an uncommanded release of the payload. The tower section landed about 20 to 30 feet north of Evan Hughes Highway on BLM land.

- Erickson Air-Crane's troubleshooting team arrived that night. The next day, June 8th, the team inspected the aircraft over a period of approximately eight hours. They found suspect wiring associated with the release control at a bulkhead connection point, which they removed and rewired.

- A biological monitor and an archeological monitor were brought to the site of the drop to assess any impacts to sensitive resources. It appears that the tower did not adversely affect any sensitive resources. Restoration of the site will be required of SDG&E

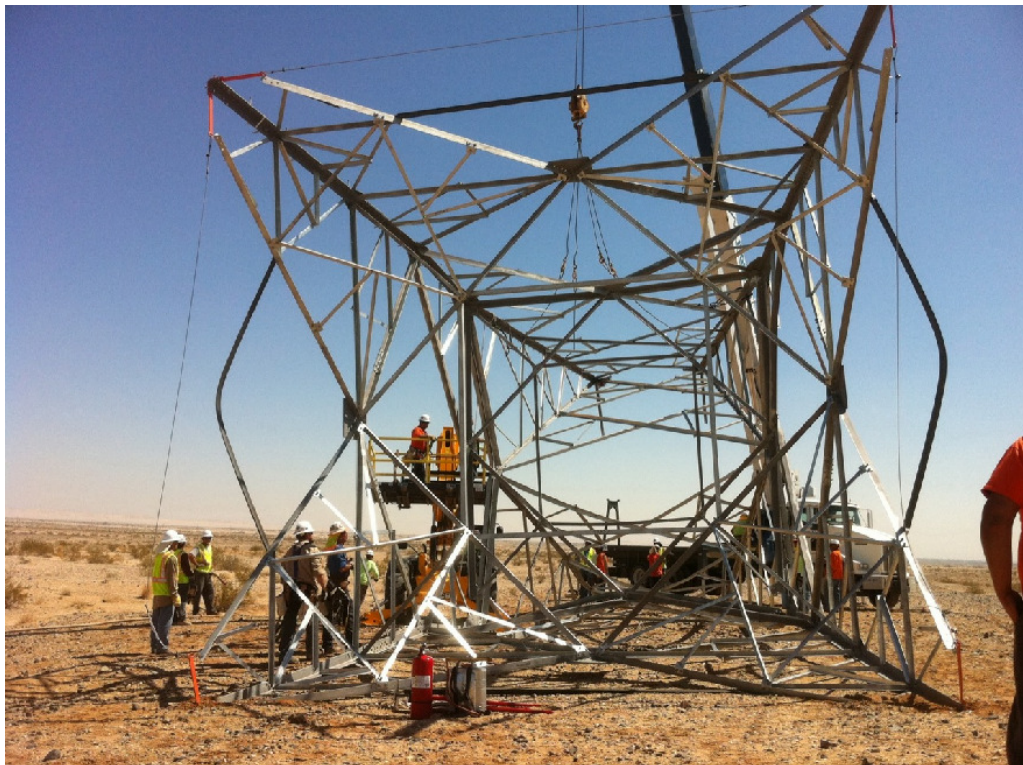
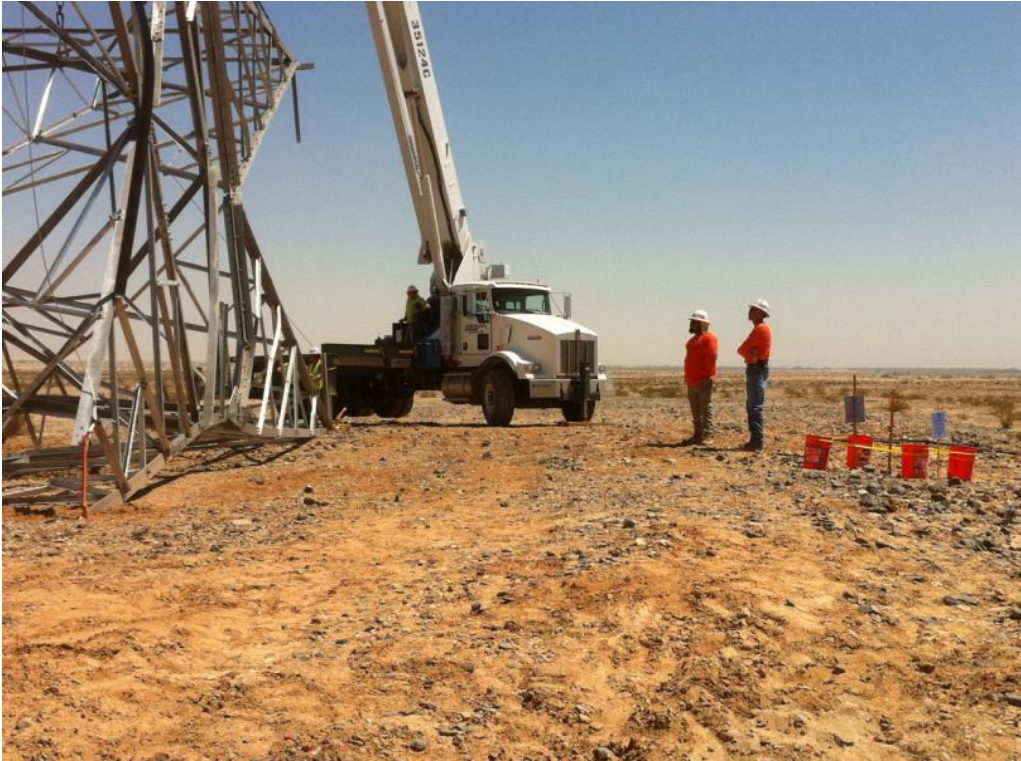
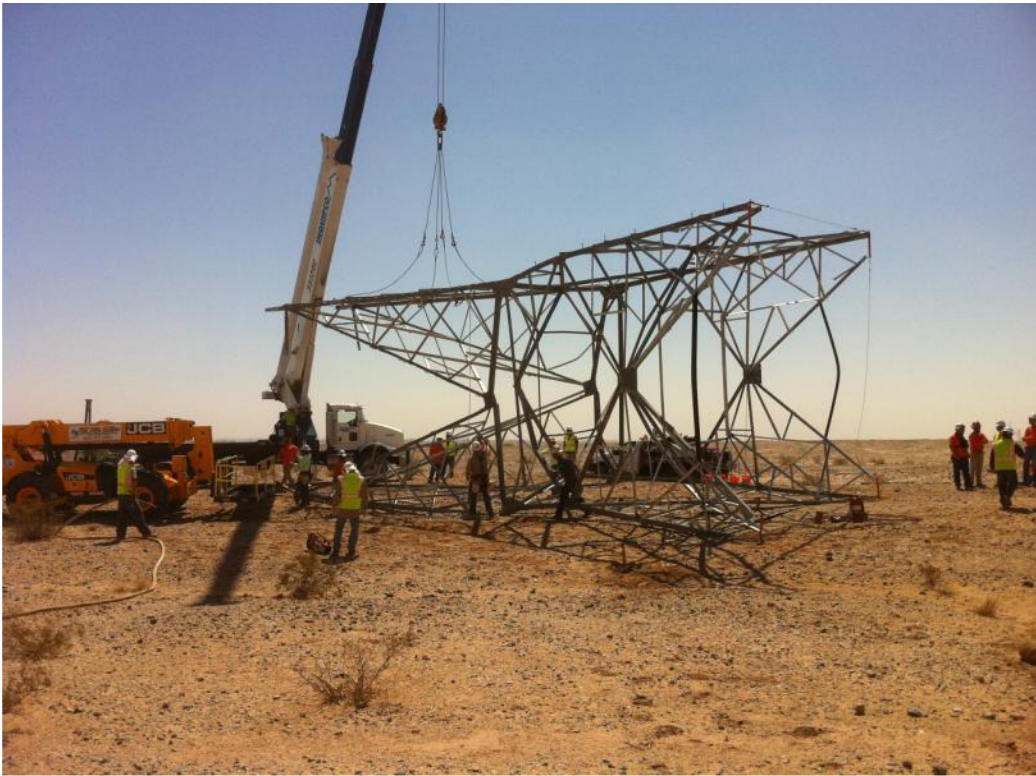
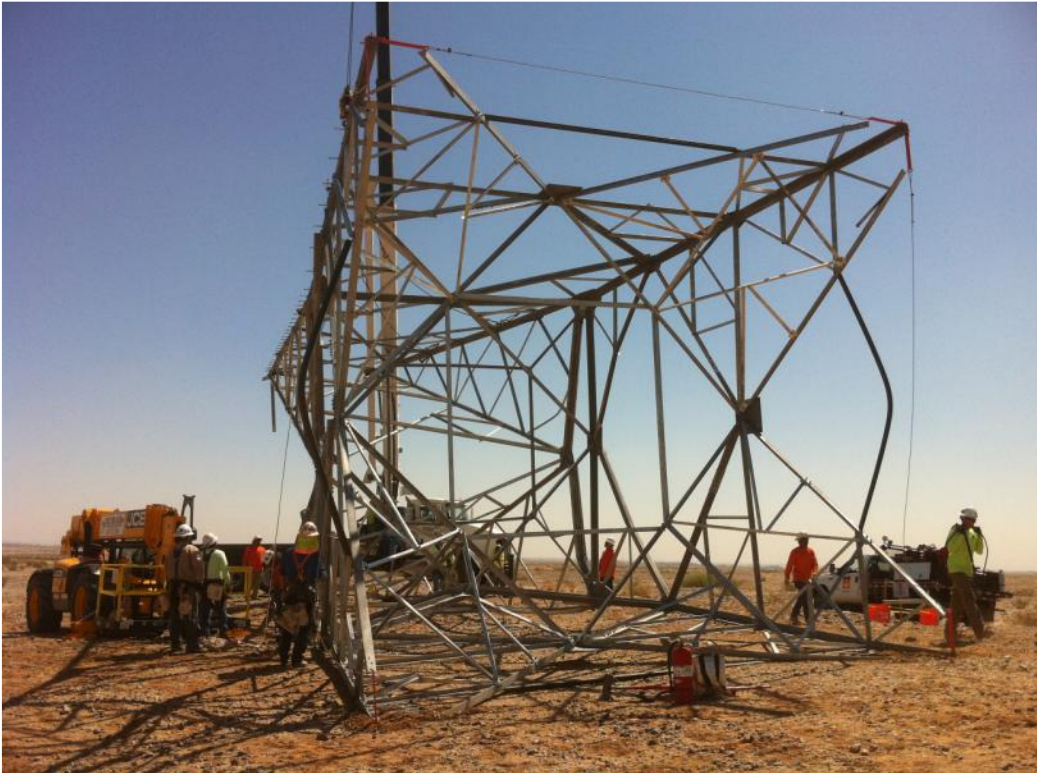
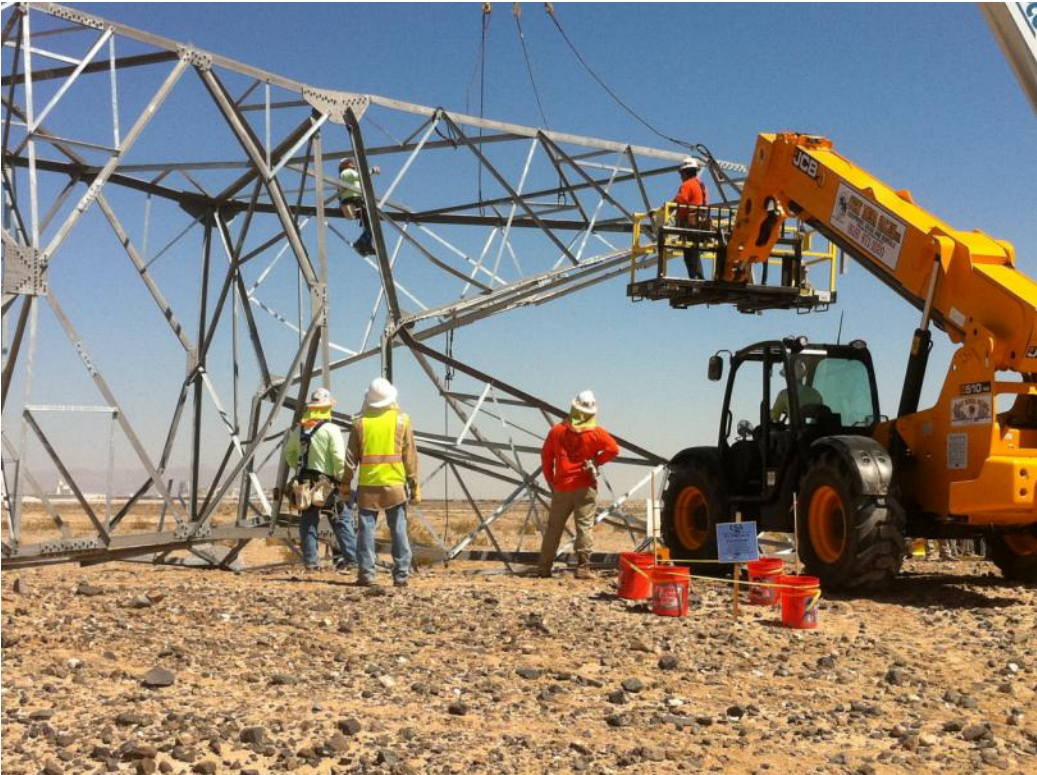
June 10, 2011 Incident

- Four lattice steel tower sections had been set in place that morning prior to the second incident.
- At approximately 8:00 AM, the helicopter was preparing to set in place a fifth section at tower site EP 339. With the section about 40 feet from the tower the crew felt a jolt and determined that three of the four hooks holding the tower section had released unexpectedly.

- After confirming the airworthiness of the helicopter, the crew lowered the tower section to the ground using the fourth hook, which took about 20 seconds. With two legs on the ground, the pilot attempted to set the tower section upright. During this part of the operation, the fourth hook made an uncommanded release and the tower section toppled.

- After determining its airworthiness, the helicopter was returned to the manufacturer, Erickson Air-Crane, in Oregon.
- At Erickson, the control mechanism is to be taken apart and inspected in order to identify the reason(s) for the releases. The FAA will be involved in this inspection. No information is available from the FAA until a final report is made, at which time the incident report will be available through a Freedom of Information Act (FOIA) request.
